CERAMIC MATERIALS IN ROLLING CONTACT BEARINGS

NORTON COMPANY

PREPARED FOR
NAVAL AIR SYSTEMS COMMAND

FINAL REPORT
Contract N00019-72-C-0299
January 3, 1972 to February 3, 1973

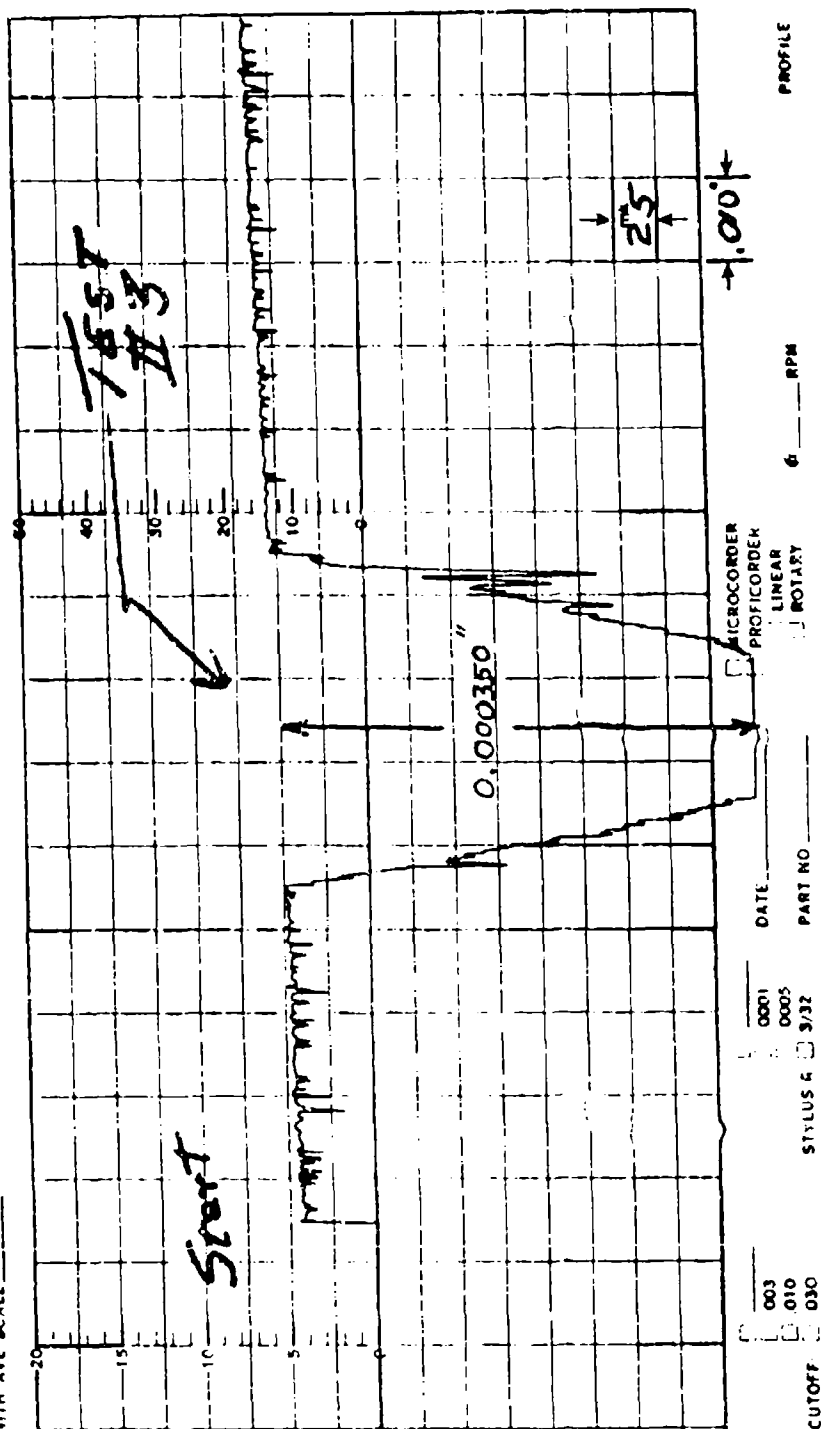
FIGURE 5

The aluminum oxide tests were generally suspended due to crushing in the ceramic contact area. Figure 5 shows a linear proficorder chart of aluminum oxide rod #1 across the contact area. Note the deep groove caused by the crushing. Compare this trace with that across an M-50 steel specimen shown in Figure 6. Because of this crushing encountered at light loads no attempts were made to run aluminum oxide at 800,000 psi Hertz stress.

69 Pounds Load, 500M PSI Hertz Stress
